# The Cause of the Collapse of Yeager Airport Extended Runway

A. S. S. Raghuram<sup>1</sup>, S.M. ASCE, B. Munwar Basha<sup>2</sup>, M. ASCE

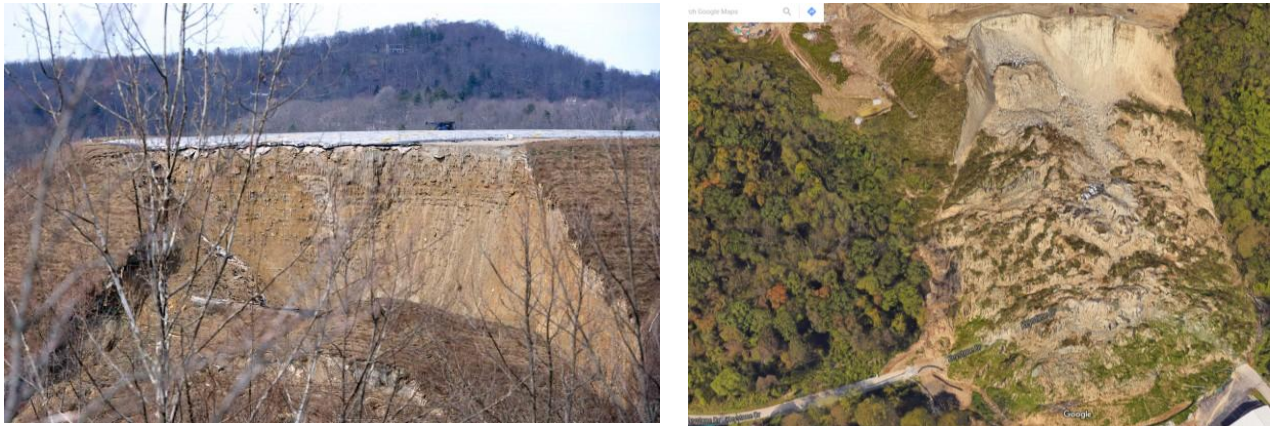
**Figure 2. The failure of Yeager airport expansion runway as reported by Charleston Gazette-Mail on 12 Mar 2015**

**Figs. 2** and **3** shows that the reinforced soil zone sheared where the reinforcement ended, and the reinforced soil as a whole is sliding down the hillside. The reinforcement is visible in the top layers, but not at the bottom. The fact is that it is at the base where the initial failure might have occurred, as this looks to be a rotational slide. The road embankment at the base of the slope as shown in **Fig. 3(a)** appears to be quite soft, with electricity poles leaning down the hill. Further,

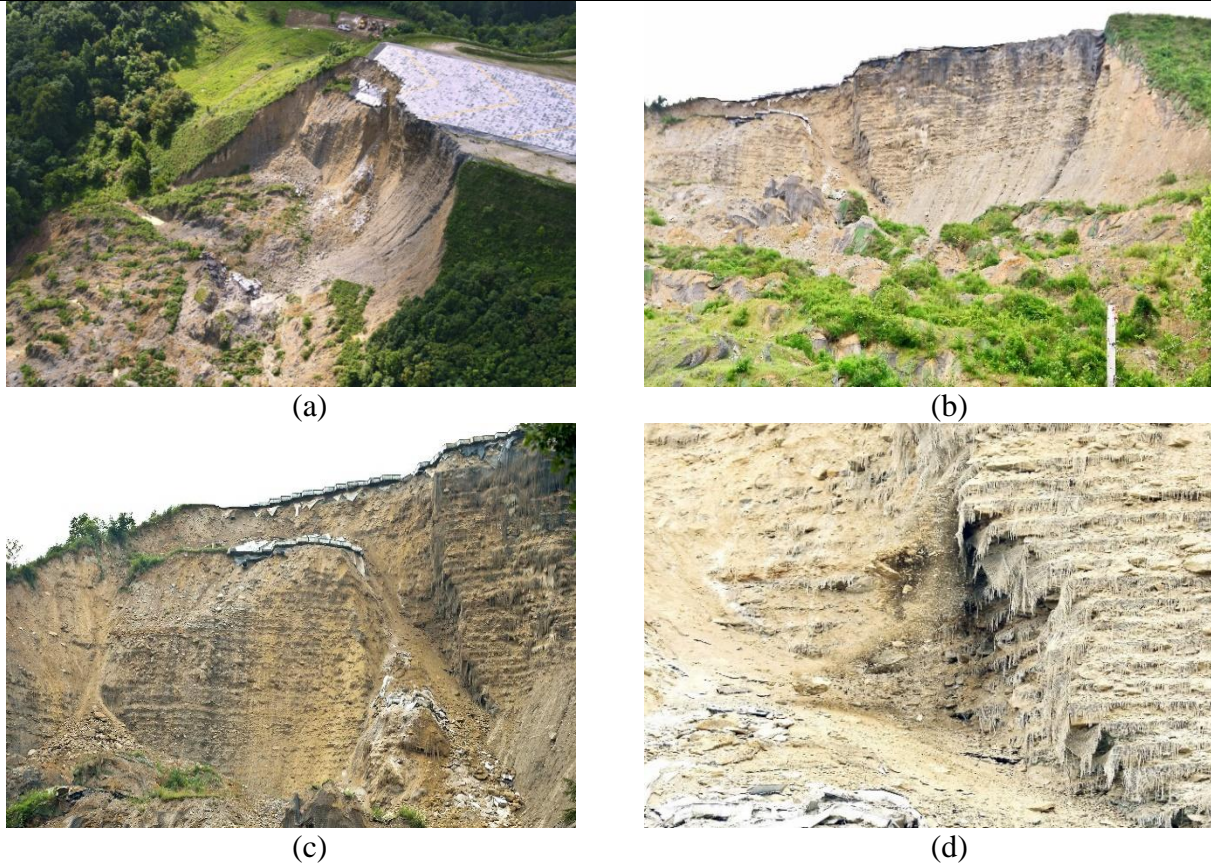
**Figure 4. Collapse of extended runway (a) View from top, (b) Long front view, (c) Close front view, (d) Failure of reinforcement**

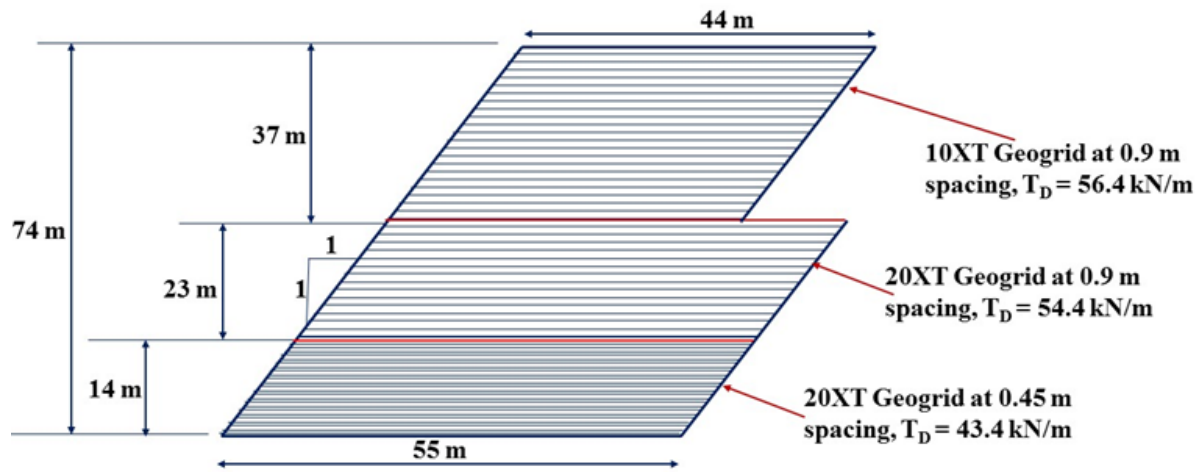
18.1, 18.1, and 22.0 kN/m<sup>3</sup>. The cohesionless is considered for all the three zones. The internal frictional angle varied as 36°, 36°, and 40° respectively for reinforced, retained and bearing soil zones. Three different types of primary and secondary reinforcement of different strengths as provided by Lostumbo (2010) are adopted for the design. The long term design strength ( $T_{all}$ ) of the reinforcements which are used for the design are provided in **Fig. 5**. The geogrids used were woven polyester uniaxial geogrids coated with PVC. As shown in the Fig. 3, the length of the geogrid varied from 44 m in the top 37 m segment at a spacing of 0.9 m and 53 m in the bottom 37 m of the segment at a spacing of 0.45 m. The minimum ultimate tensile strength of the geogrid reinforcement ( $T_{ult}$ ) used in the three zones are 160.1, 154.5, and 123.2 kN/m respectively. The actual values of  $T_{ult}$  in the three zones are 187.9, 187.9 and 145.2 kN/m respectively. **Fig. 5** clearly shows the arrangement and placement of geogrid layers as reported by Tencate.

**Figure 5. Cross section of Yeager airport extended runway slope (as reported by Tencate).**

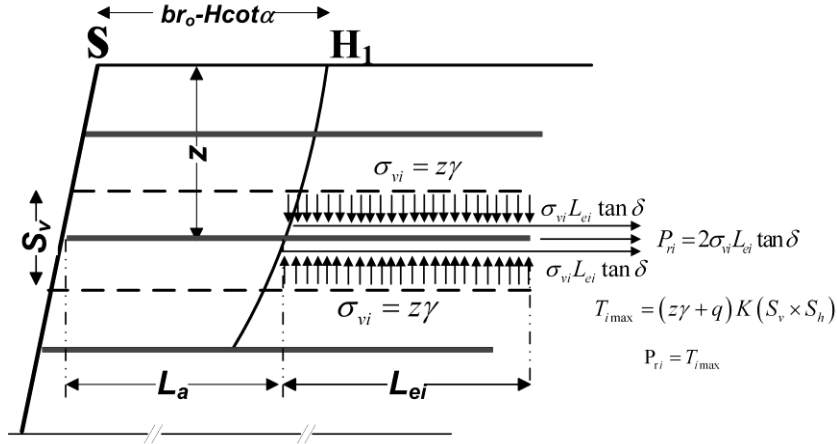
Figure. 6(b) Calculation of pullout length of reinforcement (Basha and Babu 2012)

In the analysis logarithmic spiral failure mechanism was used. The total length of reinforcement is divided in to two parts, when the log spiral failure surface passes through the toe of the reinforced wall as shown in Fig. 6(a) and 6(b). From Fig. 6(a) the total length of reinforcement can be written as

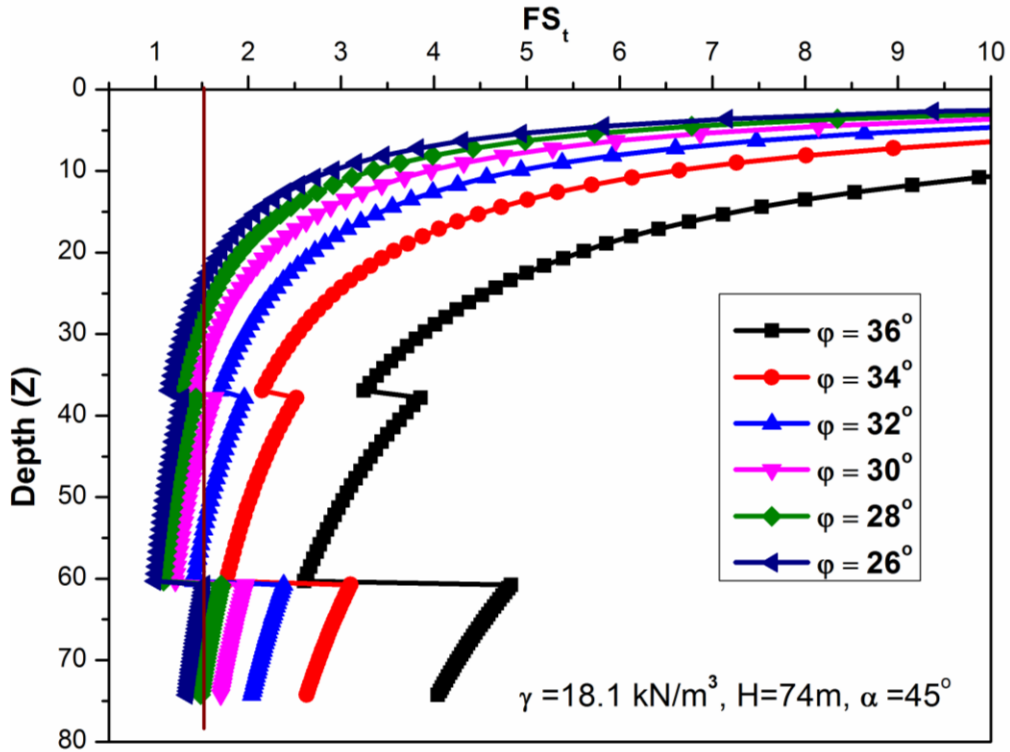
**Fig. 8(a)** shows the variation of a factor of safety against tension failure ( $FS_t$ ) of 98 layers of reinforcement along the depth of wall for  $\phi = 36^\circ, 34^\circ, 32^\circ, 30^\circ, 28^\circ$  and  $26^\circ$  and typical values mentioned in the above sections. For the top layers where an axial tensile force in the geosynthetic layer is significantly less, a very high value (i.e. 118.41) of factor of safety is observed. It can be observed from the figure that the bottom layers of reinforcement from the top of the wall are more critical to the tension mode of failure due to overburden pressure and generally have a lower factor of safety values for  $\phi \leq 30^\circ$ . The results presented in **Fig. 8(b)** show the variation of factor of safety against pullout failure ( $FS_{po}$ ) of 98 layers of reinforcement along the depth of wall for  $\phi = 36^\circ, 34^\circ, 32^\circ, 30^\circ, 28^\circ$  and  $26^\circ$ . It can be noted from **Fig. 8(b)** that the upper layers of reinforcement from the top of the wall are more critical to the pullout mode of failure and slope does not have adequate pullout length to maintain the factor of safety against pullout failure ( $FS_{po}$ ) more than 1.5 for  $\phi \leq 28^\circ$ .

Figure 8(a). Factors of safety against tension failure for different values of  $\phi$

An important conclusion that can be made from this section that the reduction in friction angle from  $36^\circ$  to  $26^\circ$  could have made the GRS critical to tension and pullout failures. However, the failure images as shown in **Figs. 2, 3** and **4** do not show any signs of either overstressing or pullout failures. Therefore, a significant reduction in friction angle is highly unlikely.

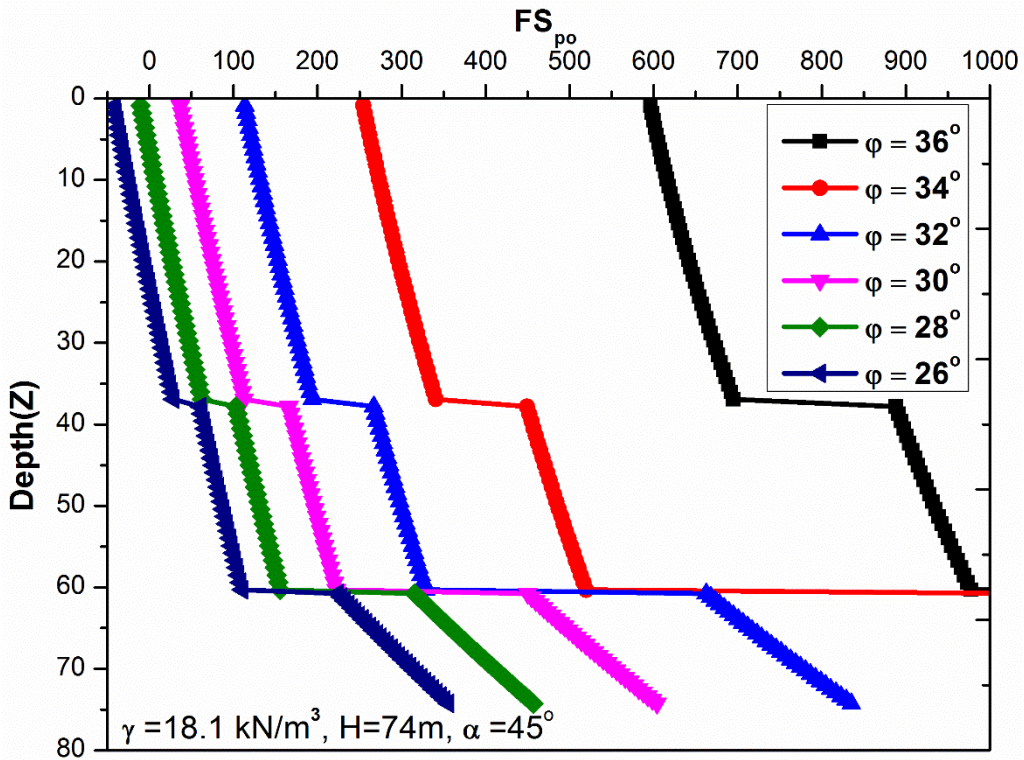
Figure 8(b). Factors of safety against pullout failure for different values of  $\phi$

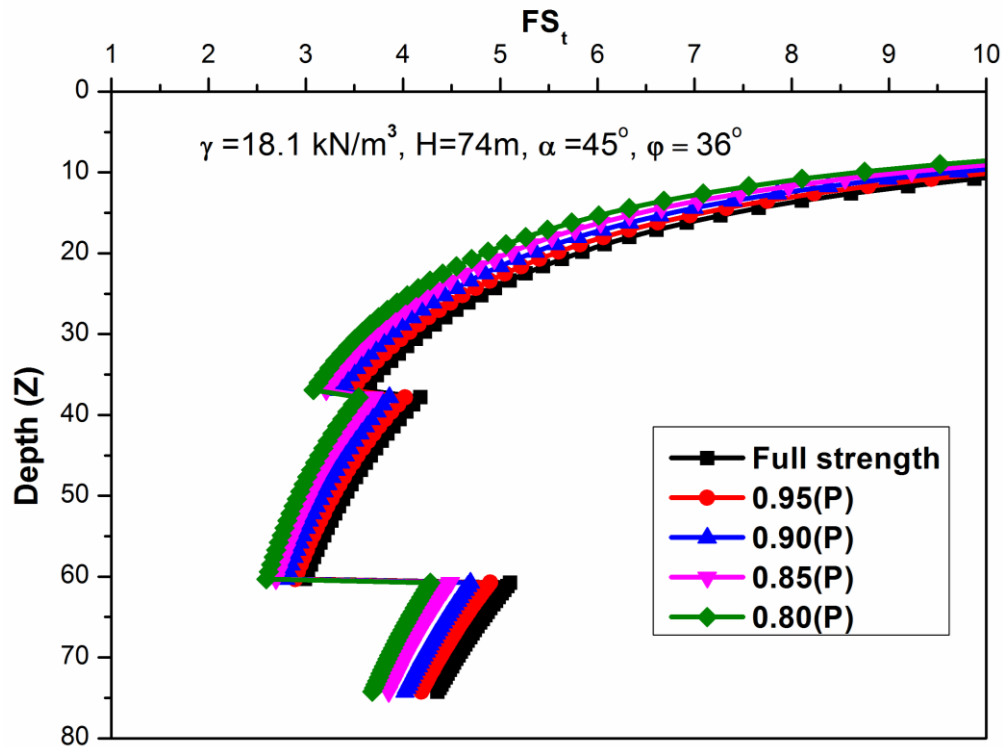
**Figure 9. Factor of safety against tension for different values of reinforcement strengths**

The reduced reinforcements strengths may be expected as there is a chance for the reinforcement to encounter the creep and biodegradation in the field. Therefore, results presented in **Fig. 9** shows the variation of a factor of safety against tension failure ( $FS_t$ ) of 98 layers of reinforcement along the depth of wall for different reduced reinforcement strengths,  $0.95 T_{all}$ ,  $0.9 T_{all}$ ,  $0.85 T_{all}$  and  $0.8 T_{all}$  and typical values adopted in the above sections. It may be noted from **Fig. 9** that the bottom layers of reinforcement from the top of the wall are not critical to the tension mode of failure due to reduction in design strength of the reinforcement from 100 to 80%. Hence, the assumption of reduction in design strength of the reinforcement is not realistic.
